SERVICE BULLETIN

SUBJECT: INSPECTION OF AUXILIARY FUEL PUMP
KNIFE DISCONNECT

MODELS
AFFECTED:

M20C 20-0010 thru 20-1222
M20E 21-0024 thru 21-1180
M20F 22-0013 thru 22-1435
M20J 24-0006 thru 24-0033
24-0035 thru 24-0038
24-0040, 24-0041, 24-0043,
24-0044, 24-0048 and 24-0052

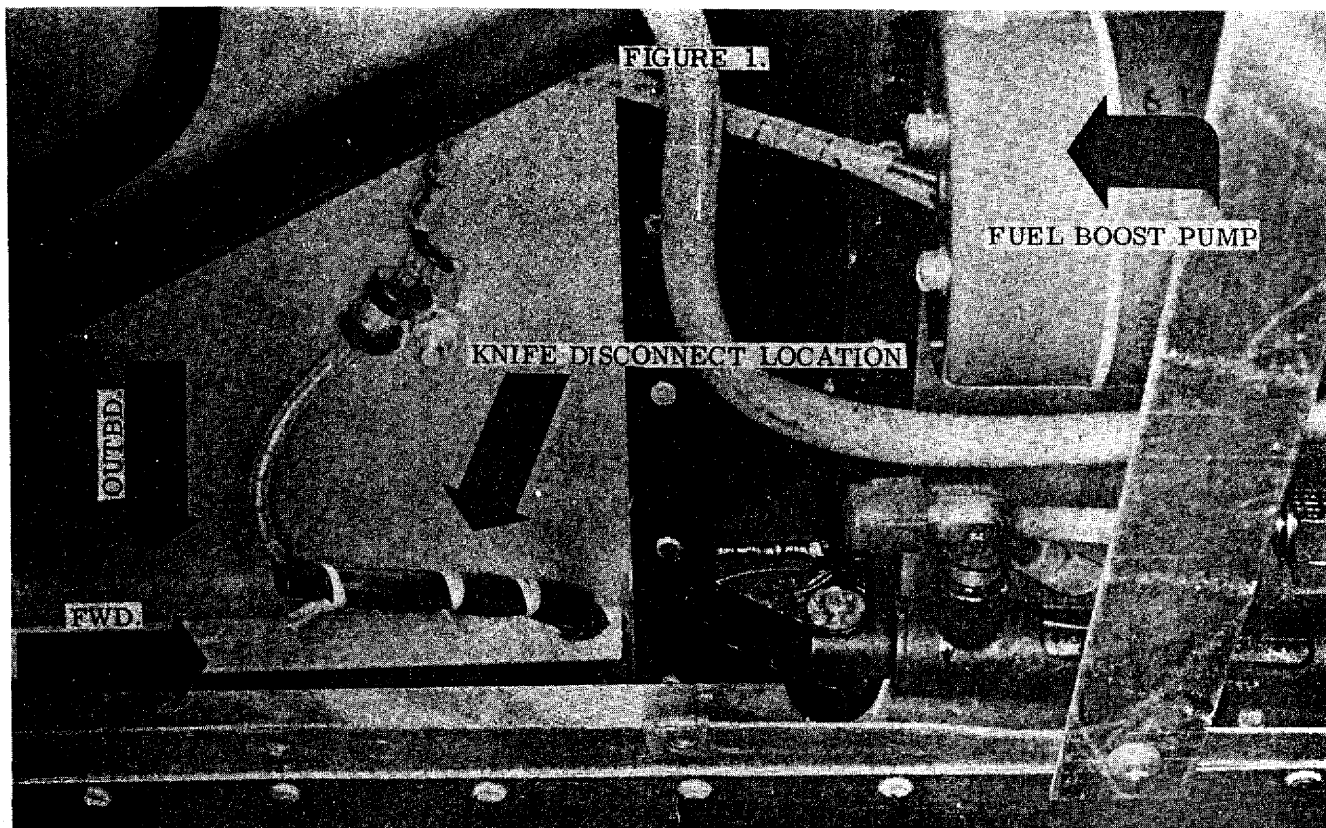
1. Verify that cockpit master switch and the boost
pump switch are in the off position.
2. Remove left exhaust cavity panel.
3. Locate the knife disconnect as shown in Figure 1.
4. Cut the Ty-Rap holding the protective cover over the
knife disconnect and slide black cover aft to expose
the knife disconnect.
5. Inspect knife disconnect for proper installation as shown
by figures 2 thru 6.

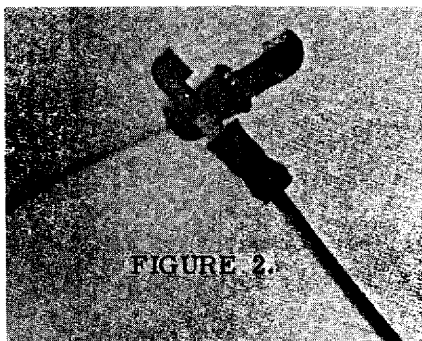
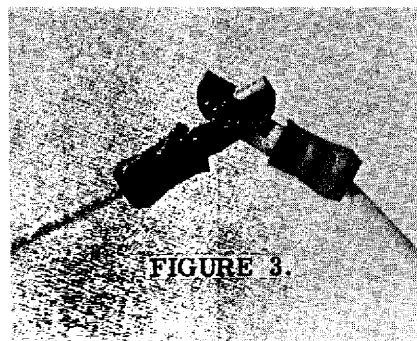
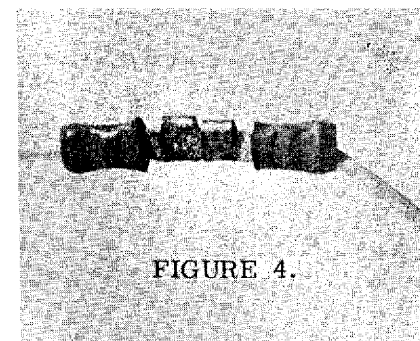
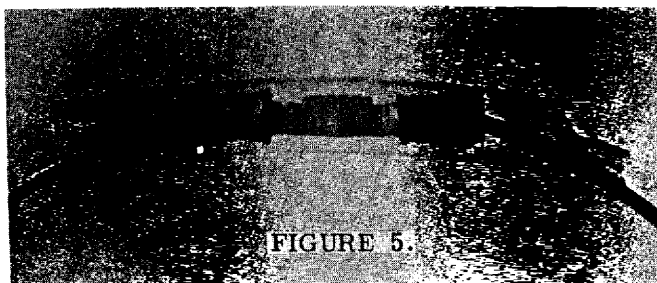
A case has been reported of the auxiliary fuel pump
failing to operate due to an improperly connected
knife disconnect. To preclude the possibility of future
occurrences of this nature the following instructions
must be complied with.

NOTE: If knife disconnect was connected by any method
other than that shown by figures 2 thru 6 replace with
new Amp 22-16-2 knife disconnects.
