SUBJECT: LANDING GEAR SAFETY SWITCH OVERRIDE

MODELS AFFECTED: M20C 700055 thru 20-1233
 M20E 700035 thru 21-1180
 M20F 700038 thru 22-1441
 M20J 24-0001 thru 24-0237

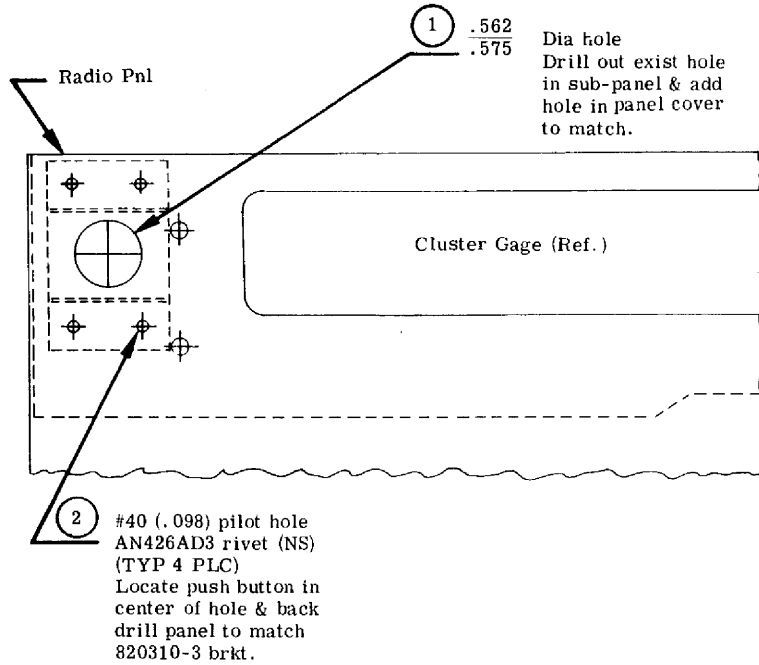
FIGURE II

M20C - 700055 thru 20-1146
 M20E - 700053 thru 21-1160
 M20F - 700038 thru 22-1178

- (3) Install by-pass switch assembly in panel per Figures II thru V. Connect ground wire #21WE36B22 to airframe ground. (Select figure applicable to your serial number aircraft.) Route and secure wires SB-M20-196-3, SB-M20-196-4, and SB-M20-196-5 with existing wire bundle forward to firewall and down to left wing plug.

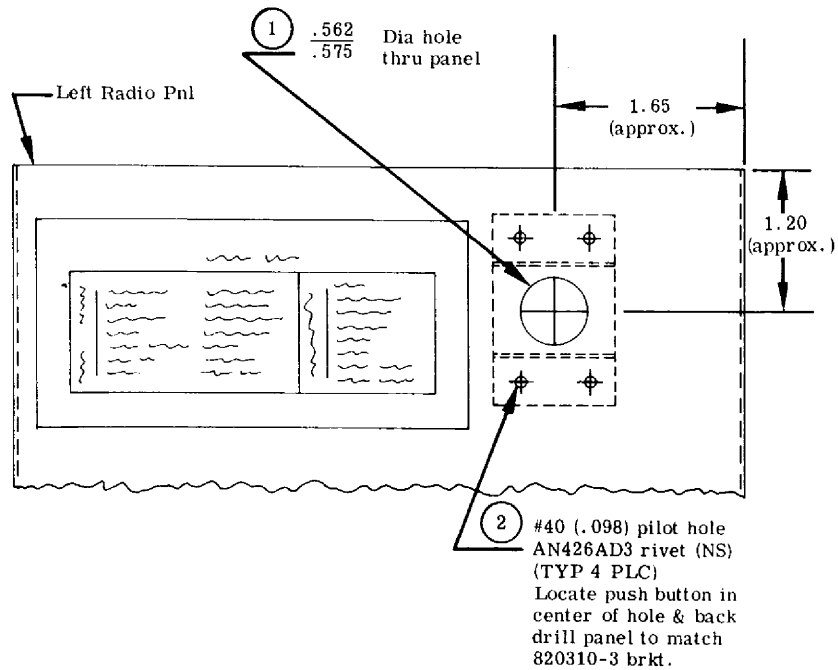
FIGURE III

M20C - 20-1147 thru 20-1185
 M20E - 21-1161 thru 21-1180
 M20F - 22-1179 thru 22-1305 (except 22-1246)

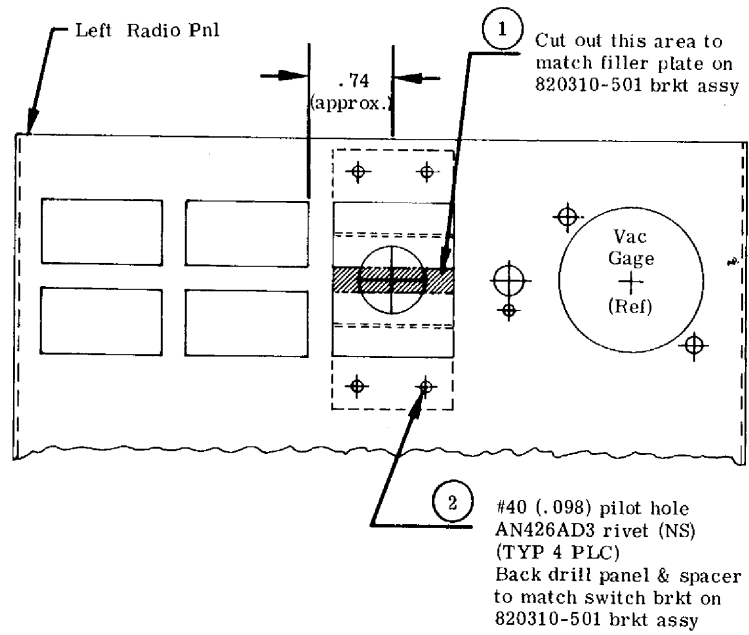
FIGURE IV

M20C - 20-1186 thru 20-1233
M20F - 22-1246, 22-1306 thru 22-1441

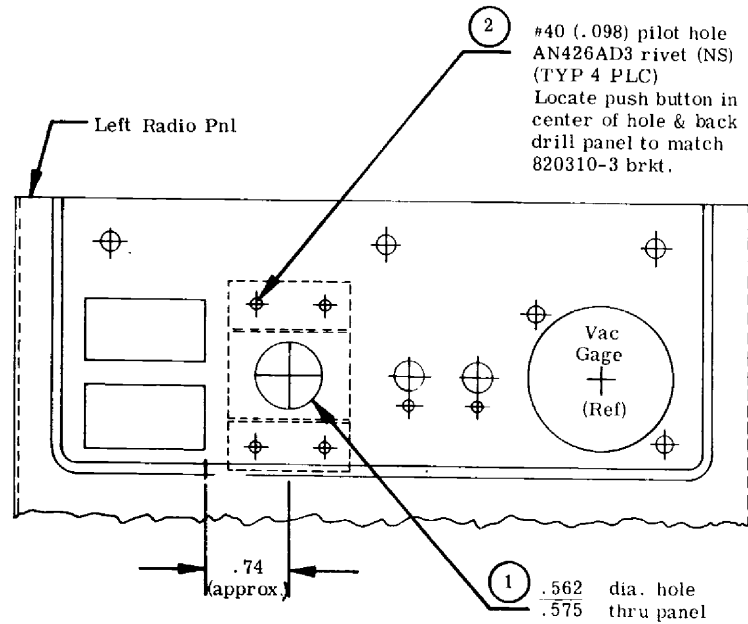
FIGURE V

M20J - 24-0001 thru 24-0237
