SERVICE BULLETIN

SUBJECT: FINGER STRAINER INSPECTION

AFFECTED: M20F - 22-1430 thru 22-1439
M20J - 24-0006 thru 24-0083,
24-0085 thru 24-0121,
24-0123 thru 24-0257,
24-0259 thru 24-0280,
24-0282, 24-0283,
24-0285 thru 24-0289,
24-0293 thru 24-0296

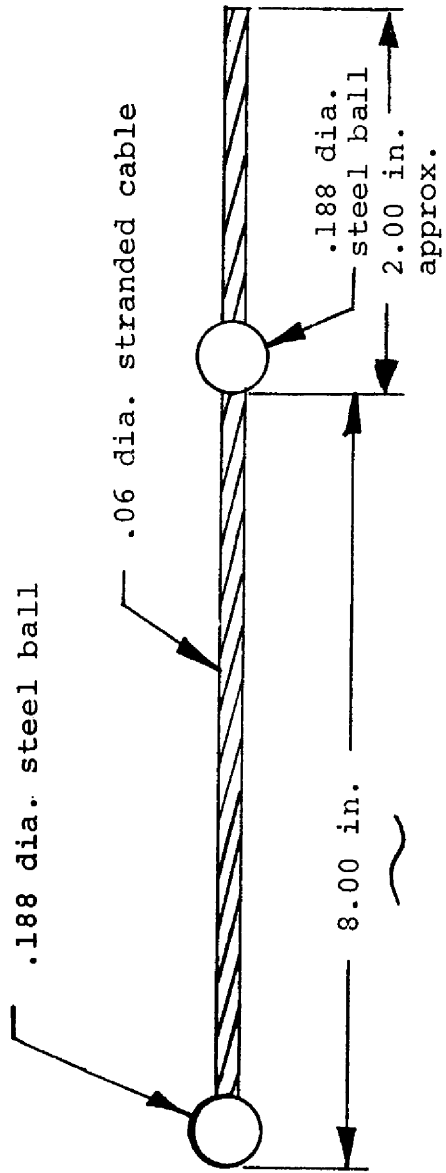
M20-207-1 Test Probe

Some fuel tank finger strainers P/N 610150-1 (left) and 610150-2 (right) have been manufactured with excessive solder which could partially block the tube opening. Other tank finger strainers may have been damaged on installation. Either condition could cause a fuel flow restriction to the engine.

5. Insert test probe (ball end first) P/N M20-207-1 in each tank outlet; probe will enter to second ball on cable if the tank outlet finger strainer assy is satisfactory. If probe will not enter tank outlet to second ball, then the tank outlet must be removed and replaced.
