A CANAL PROPERTY

SEAT LIMIT STOPS

M20J S/N 24-0361 thru 24-0387, 24-0389 thru 24-0394, 24-0396 thru 24-0403, 24-0405 thru 24-0412, 24-0414, 24-0416, 24-0418 thru 24-0422, 24-0424, 24-0425, 24-0427 thru 24-0430, 24-0435, 24-0435, 24-0433

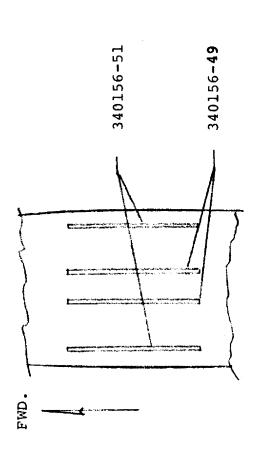
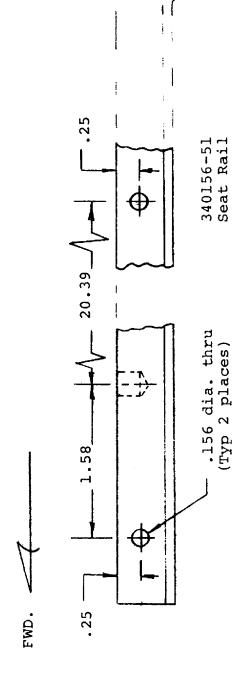
FIGURE 20-211-1

To prevent the possibility of the pilot and copilot seats coming off the seat rails during adjustment, the following modification should be accomplished:

- a) Remove the four cotter pins from the forward and aft end of the two inboard seat rails (340156-49).
- b) Remove the pilot and copilot seats.
- c) Drill 2 each .156 dia. holes in each outboard seat rail (340156-51) as shown in Figure 20-211-1, paying particular attention to the .25" dimension.

NOTE: Do not use existing holes as reference.
- d) Replace seats.
- e) Install AN 380-5-3 cotter pins in each newly drilled hole, 4 places.
- f) Fill out log book and return compliance card.
