SUBJECT: SEAT BELT LATCHING MECHANISMS,
INSPECTION AND MODIFICATION

MODELS/
SERIAL NUMBERS
AFFECTED: Mooney M20J S/N 24-0985, 24-0986, 24-0988 thru
24-0994, 24-0998 and 24-1000
Mooney M20K S/N 25-0361 thru 25-0363,
25-0366, 25-0368, 25-0370,
25-0371, 25-0374 thru 25-0379,
25-0383, and 25-0385 thru
25-0388

SERVICE BULLETIN

SUBJECT: Possible Improper Latching of Seat Belt Assemblies
FDC-5900-160-4 and FDC-5900-160-6

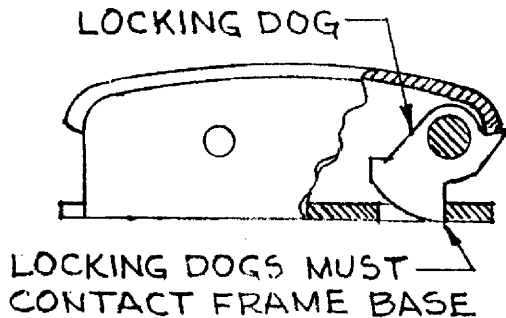
Sketch A

We have found that the release fitting may latch improperly when inserted into the buckle. Improper latching exists if both locking dogs are not engaged with the release fitting. (Note: FAA strength requirements are met even if only one locking dog is engaged.)

To inspect for improper latching, insert the release fitting into the buckle and observe the locking dogs through the rectangular slots in the base of the buckle. If properly engaged, the locking dogs will make contact with the buckle frame base. (Sketch A)
