NUMBER: S.B. M20-224

DATE: 9-23-80

SUBJECT: FUEL FLOW TRANSDUCER, AEROSONIC PART NO. 32622-6

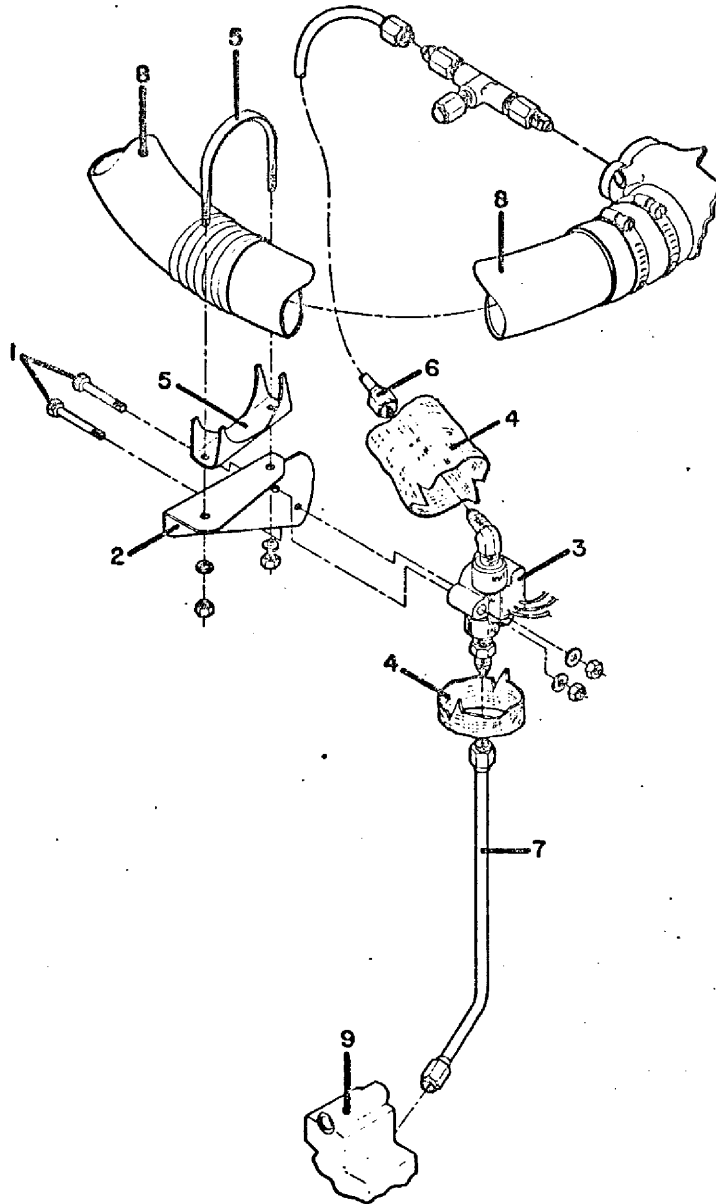
FIGURE 1

It has been determined that certain transducers manu-
factured by Aerosonic were improperly assembled and on
some installations may leak or come apart during engine
operation. This Bulletin requires inspection and
replacement of suspect transducers on above aircraft
serial numbers.

- 4) Loosen the nuts on the C10Y-34-6S clamp assy and rotate bracket and clamp so the back side of the transducer is exposed. Inspect for the name "FLOSCAN" embossed on the backing plate of the transducer housing. If the name "FLOSCAN" is found on unit it does not need replacing.

- 5) If no name is found on the backing plate, the transducer must be removed and replaced with a "FLOSCAN" unit.
 - a. Disconnect the fuel lines from the transducer ports.

- b. Remove sleeving from knife blade type connections and disconnect.
- 6) Install and secure the new transducer and leak check all fuel fittings prior to covering with the firesleeve. Install 45° elbow and union to transducer to a minimum torque of 40 inch/lbs., rotate to index to position. If leak persists, tighten one full turn, do not overrun or back off. Torque fuel line flare nut fittings to 50-90 inch/lbs.
