SUBJECT: KING RADIO SERVICE BULLETIN KS 177/178-3 "ALERT" AND FAA AIR-
WORTHINESS DIRECTIVE 85-25-02

**MODELS &
S/N's AFFECTED:** Applies to Mooney Models M20J and M20K aircraft listed below which have
King KAP 100, KAP 150 and KFC 150 autopilots installed and any Mooney
which may have had one of these autopilots field retrofitted.

SB KS 177/178-3 "ALERT" Supplement

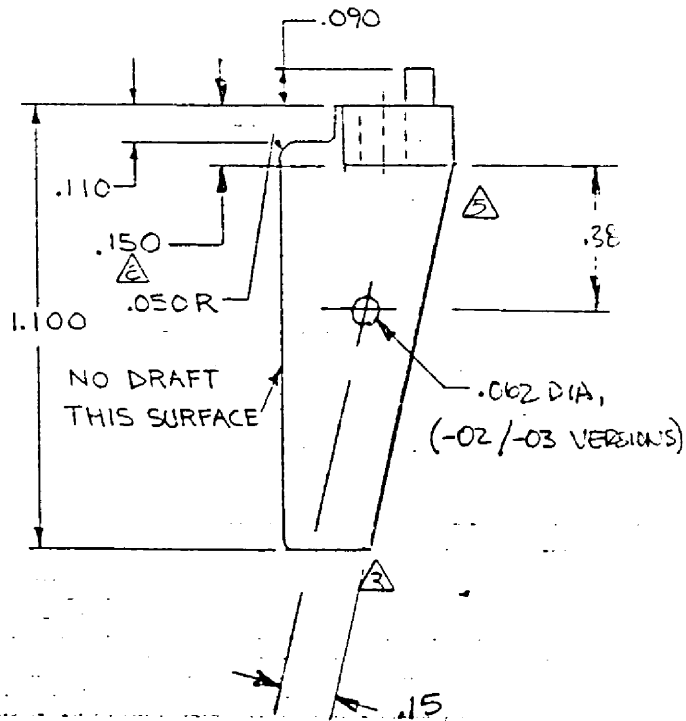
INTRODUCTION: To prevent loss of primary pitch and/or roll control contact your nearest King
Service Center for modification of servo.

1. The cable guard may be drilled with a .062 diameter drill referencing the figure below for hole location.

2. A MS 35265-14 or equivalent may be used instead of a KPN 089-6109-05 screw.
