SERVICE BULLETIN M20-253 A
DATE: 12-95

SUBJECT: M20J ALTERNATE AIR DOOR RETROFIT

MODEL/
S/N AFFECTED: M20J - S/N 24-3244 THRU 24-3250, 24-3252 THRU 24-3374

AD #
95-26-16
121

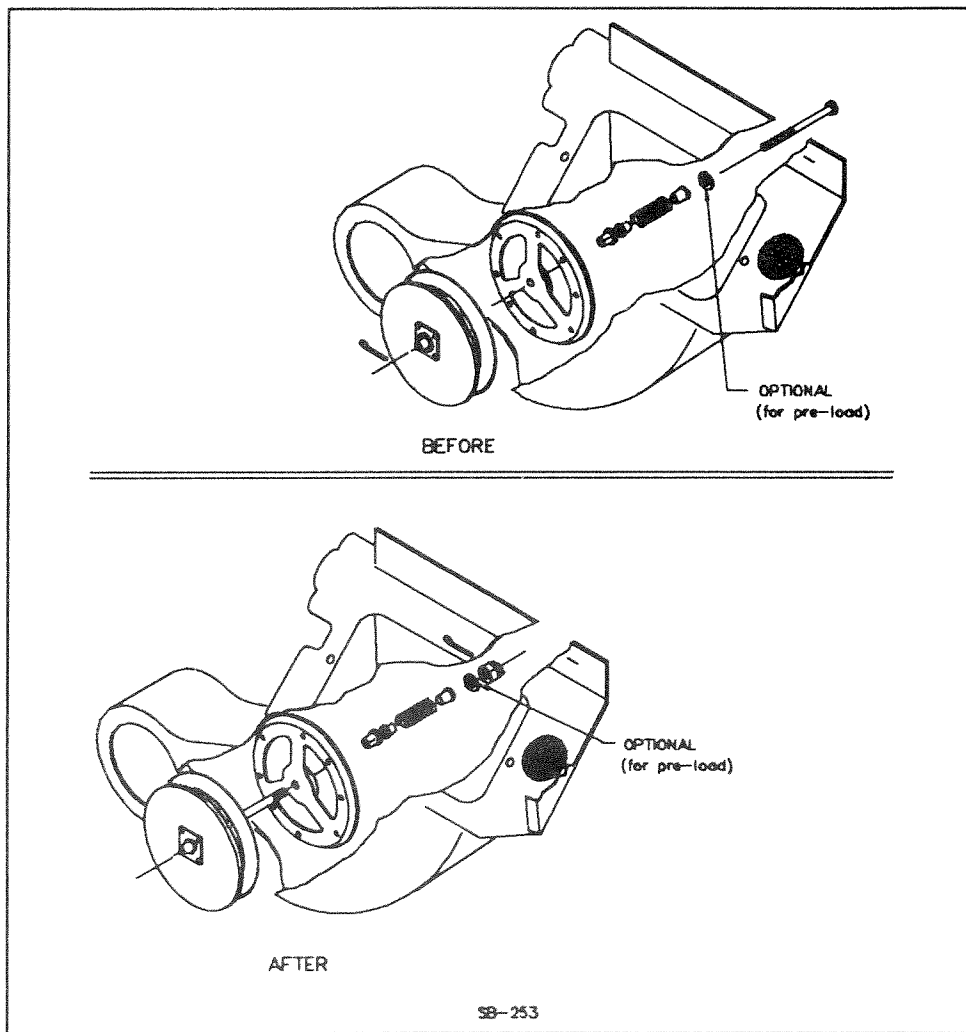
There has been a report of the alternate air door lodging in the induction air duct and restricting induction air flow to the engine. The bolt threads within the modified nut became worn due to vibration. This SB is to change the configuration of the plate assembly and reduce the possibility of this occurring.

SEE
BEFORE AND AFTER
CONFIGURATIONS,
IN FIGURE
SB M20-253 A-1

8. Insert bolt shank of new 600355-507 plate assembly (included in kit) into hole of alternate air door, 600118-015 (from opposite side of rubber seal). Use 4 MS20426AD3 rivets (included in kit) to fasten plate assembly to alternate air door. Use next oversize rivets, if necessary. Align bolt in center of hole as components are being riveted together. Use existing rivet holes in 600118-015 alternate air door. *RIB EC1300 OR EC1300L ADHESIVE*

10. Re-assemble alternate air door assembly (on forward side of aft wall of duct) to doubler assembly (on aft side of aft wall of duct) with nylon bearings, sleeve, spring, **new self-locking/castellated nut (MS17825-4)** and **new cotter pin** (new nut and cotter pin included in Revision A kit).
