SERVICE BULLETIN M20-276

Date: December 18, 2000

SUBJECT: OVERHEAD TUBULAR STRUCTURE MODIFICATION

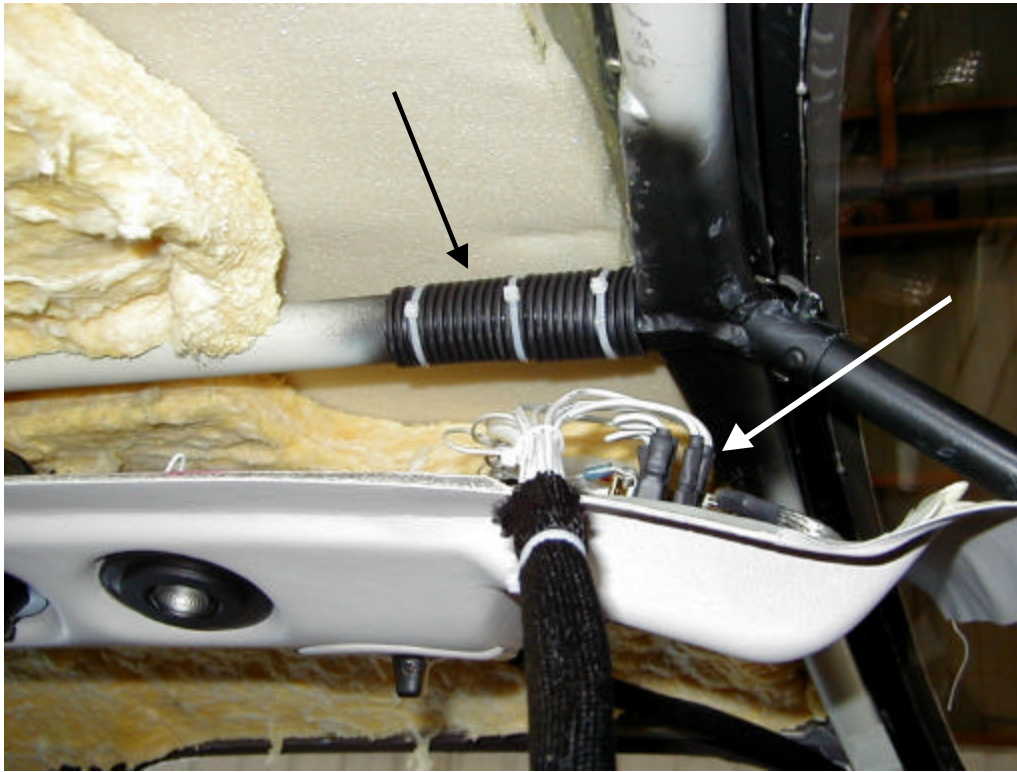
Figure M20-276-1

INTRODUCTION: It has been determined that the possibility of arcing between the headliner assembly bus bar (associated with the overhead light switches) and the overhead tubular structure exists in the affected aircraft. This service bulletin provides for inspection of the overhead area and installation of split loom tubing over part of the overhead tubular structure to prevent inadvertent arcing from either of the headliner assembly bus bars.

2. Drop headliner assembly down far enough to access overhead tubular structure (figure M20-276-1 (black arrow)).
3. Inspect electrical wiring connection area associated with the headliner forward switches (figure M20-276-1 (white arrow)) for evidence of arcing and replace any affected components, as necessary, per the individual aircraft's Service and Maintenance manual.
4. Insert a 3 inch long piece of 1.000" black heat stabilized nylon split loom tubing between station 31.00 and 34.00 (figure M20-276-2) on the overhead tubular structure, which runs down the middle of the headliner assembly.
5. Secure split loom tubing to overhead tubular structure with nylon wire ties as required (figure M20-276-3).
6. Reinstall headliner assembly per respective aircraft's Service & Maintenance Manual.
7. Reconnect battery(s) to aircraft.
