SUBJECT: Empennage Trim Fitting And Mounting Hardware Inspection

MODELS/ SN AFFECTED: ALL Mooney M20B - M20C - M20D , M20E - M20F - M20G - M20J - M20K  
M20L, M20M, M20R, M20S, M20TN

TIME OF COMPLIANCE: **WITHIN NEXT 10 FLIGHT HOURS - UNLESS ALREADY ACCOMPLISHED**  
**This is a one time inspection**

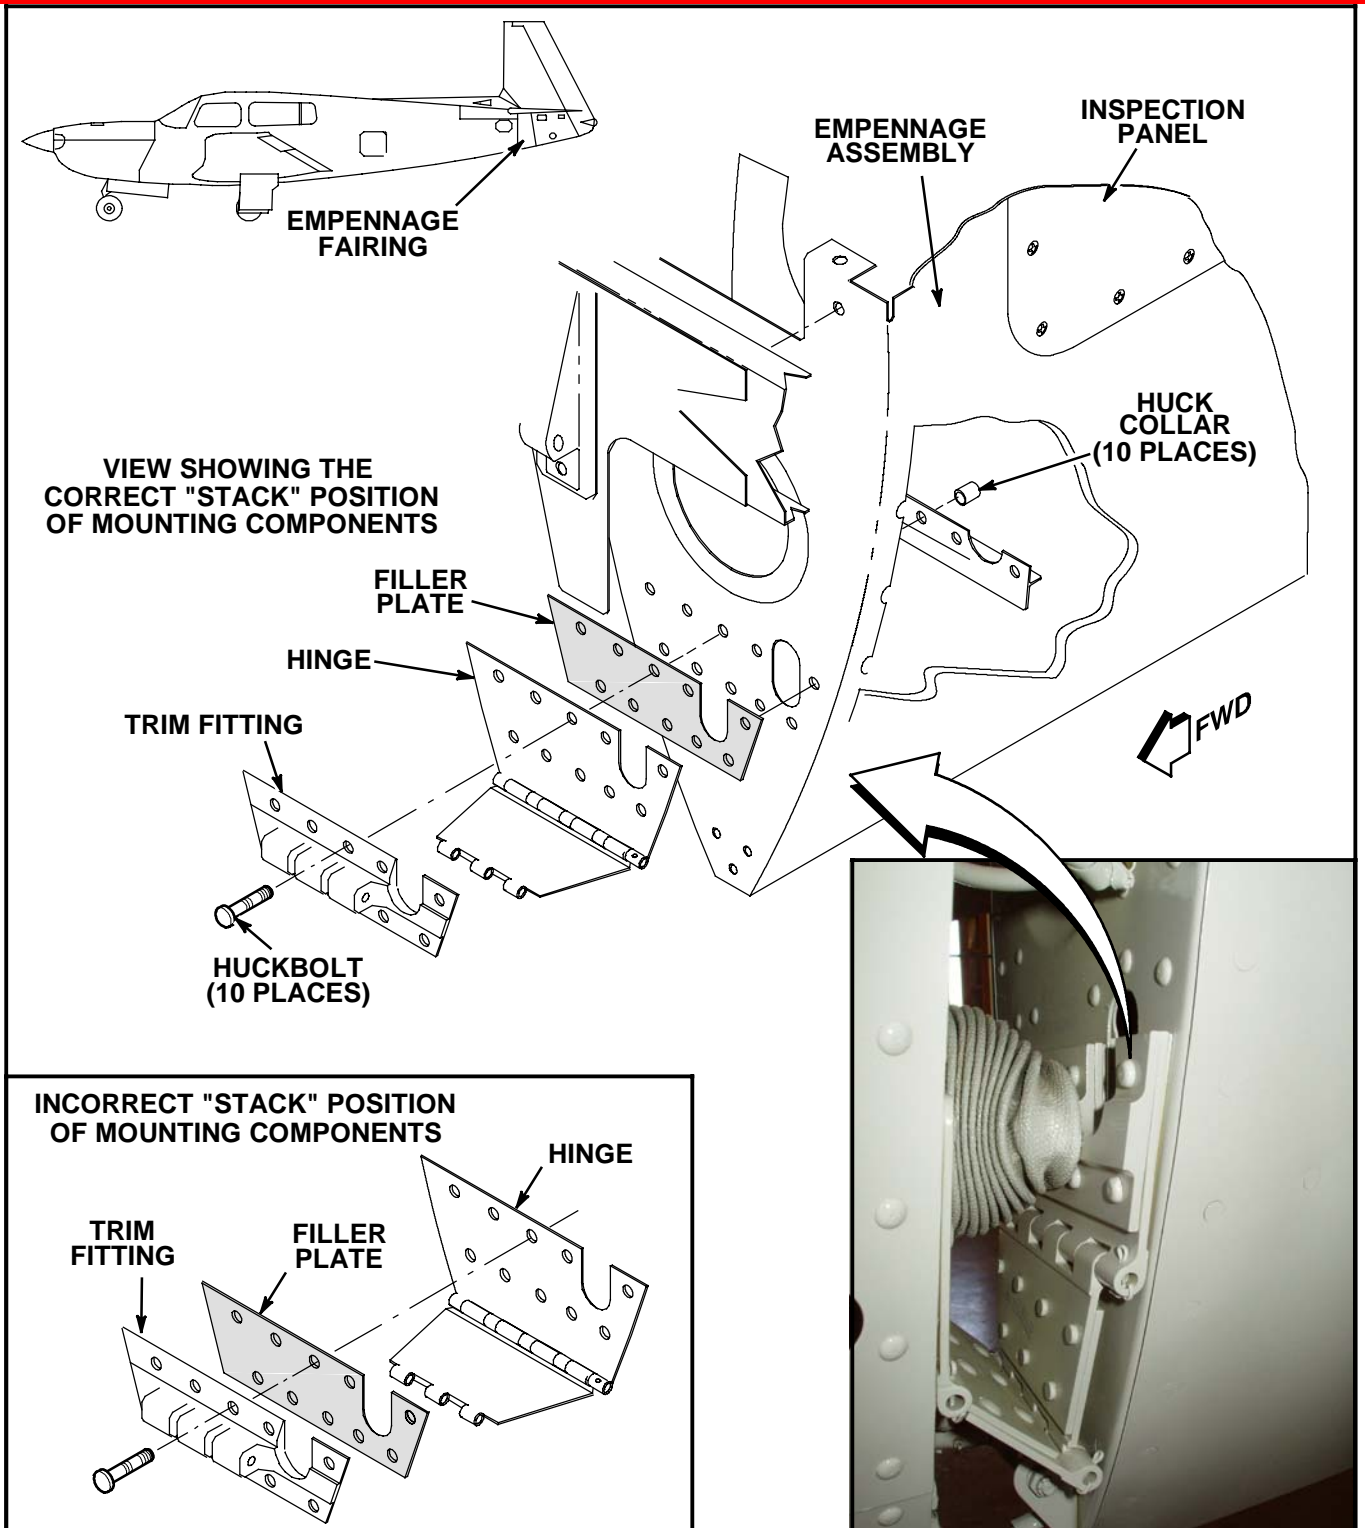
Figure SB M20-313-1 - EMPENNAGE TRIM FITTING AND MOUNTING HARDWARE

INTRODUCTION: There have been reports in the field of the trim filler plate mounting (stacked with the trim fitting and trim hinge) positioned incorrectly on the M20J, M20R and M20TN Mooney Airplanes. We are issuing this Service Bulletin because we evaluated all the relevant information and determined the unsafe condition described in SB M20-313 (initial release) is likely to exist in other products of the same type design. This will require an inspection and corrective action taken. **The attached compliance card needs to be filled out and returned to Mooney Aviation Company upon completion of this Service Bulletin M20-313A.**

- 1.1. Turn master switch - OFF.
- 1.2. Remove LH and RH empennage fairing refer to Figure M20-313-1.
- 1.3. Visually inspect the position of the filler plate as shown in Figure M20-313-1.

- 1.4. If the trim fitting, hinge and filler plate are found to be in the "Correct" position as shown in Figure M20-313-1, continue to steps 1.6 of this bulletin.

- 1.6. Remove LH inspection panel on empennage assembly, refer to Figure M20-313-1.
- 1.7. Visually inspect all 10 huckbolts to insure no signs of movement, retaining collar properly swedged and visually verify pin protrusion (use inspection mirror for lower bolts). Make sure all hardware is secure, bolts and collars should not rotate with finger pressure, hinge assembly should not move on bulkhead - refer to Figure M20-313-1.

- 1.5. If the trim fitting, hinge and filler plate are found to be in the "Incorrect" position as shown in Figure M20-313-1, DO NOT FLY - Please contact Mooney Technical Support at 830-896-6000 or email [technicalsupport@mooney.com](mailto:technicalsupport@mooney.com) for further instructions.

- 1.8. If the hardware is found to be "secure" - continue to steps 1.10 of this bulletin.
- 1.9. If the hardware is found to be "insecure" - DO NOT FLY - Please contact Mooney Technical Support at 830-896-6000 or email [technicalsupport@mooney.com](mailto:technicalsupport@mooney.com) for further instructions.
