SUBJECT: Empennage Trim Fitting And Mounting Hardware Replacement Instructions - from Mooney Aviation Company's Service Bulletin M20-313.

MODELS/ SN AFFECTED: ALL Mooney M20B - M20C - M20D , M20E - M20F - M20G - M20J - M20K M20L, M20M, M20R, M20S, M20TN

TIME OF COMPLIANCE: **MANDATORY BEFORE NEXT FLIGHT -**

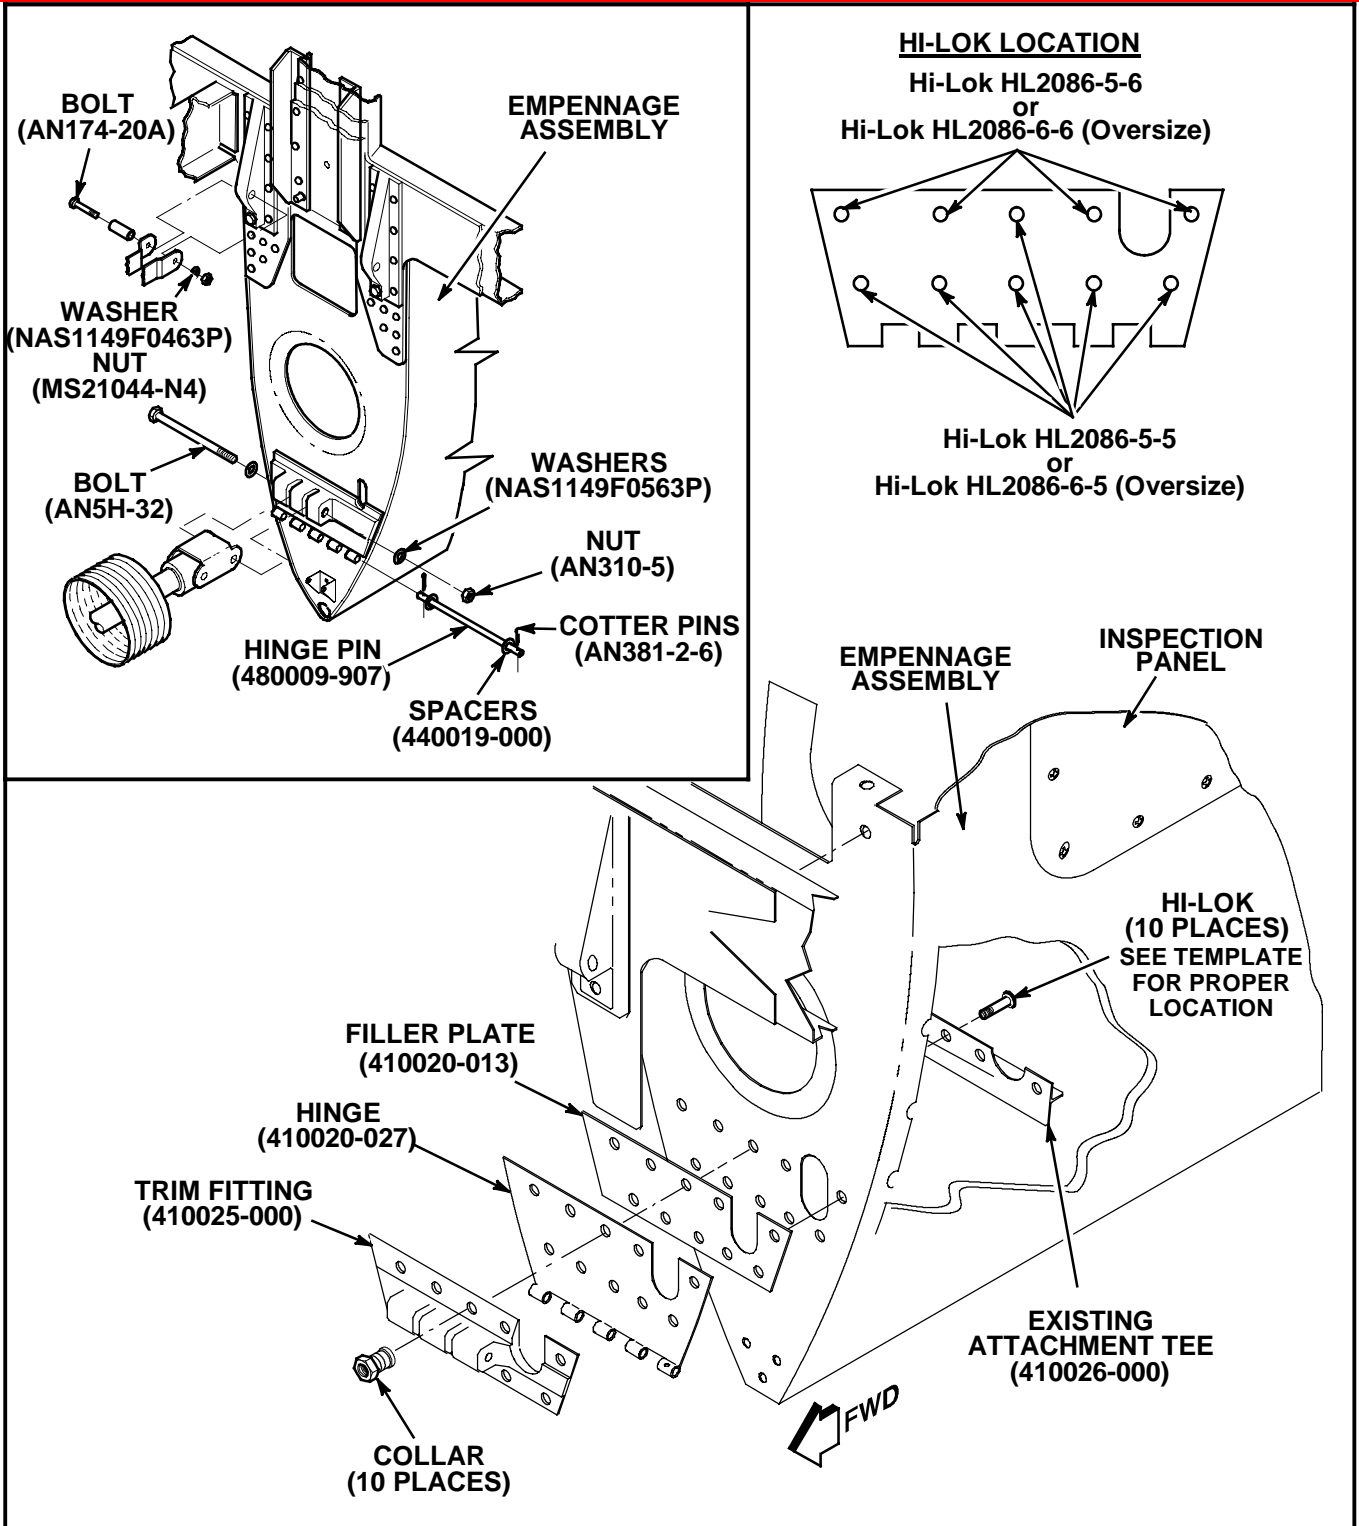
Figure SB M20-314-1 - EMPENNAGE TRIM FITTING AND MOUNTING HARDWARE

INTRODUCTION: This service bulletin is to repair the trim filler plate mounting (stacked with the trim fitting and trim hinge) when found to be positioned incorrectly as referenced in Service Bulletin M20-313. **The attached compliance card needs to be filled out and returned to Mooney Aviation Company upon completion of this Service Bulletin M20-314.**

- 1.8. Using the new parts from the M20-314-001 kit, stack components: Trim Fitting (p/n 410025-000) Hinge (p/n 410020-027) and Filler Plate (p/n 410020-013) then match drill all components to existing structure, refer to Figure M20-314-1.

- 1.10. Secure new parts with new (4 qty) Hi-Lok (p/n HL2086-5-6) and (6 qty) Hi-Lok (p/n HL2086-5-5) fasteners into place as required. The orientation of hardware is reversed for ease of installation, refer to Figure M20-314-1.
