S.I. M20-55

SUBJECT: Instrument Panel and Glareshield Lights, Light Control Rheostat Wiring Modification.

**MODELS/
SERIAL NUMBERS
AFFECTED:** Mooney Models M20J, S/N 24-0927 through 24-1085, M20K, S/N 25-0280 through 25-0542.

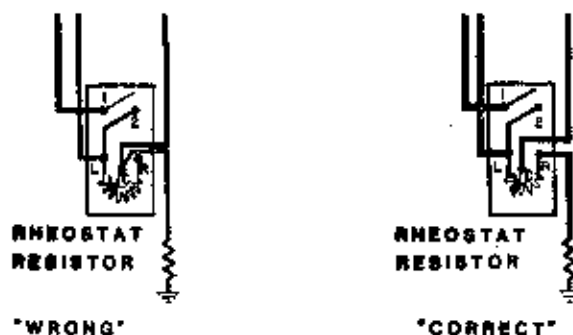
Figure A

INTRODUCTION: An error in the subject light control rheostat wiring will cause excessive current to be drawn through the rheostat and bias resistor when the lights are turned up toward the "BRIGHT" end of the control. This can result in shortened life of these components due to heat. It is recommended that the wiring connection between the resistor and the rheostat be inspected and changed per the following diagrams if necessary.

INSTRUCTIONS: Look under instrument panel, with appropriate light source, to determine if wiring between resistors and rheostats is properly connected. The wire from the resistor should be connected to the "R" terminal on the rheostat. Some have been found connected to the "C" terminal which causes the condition described above. See Figure "A" for proper connections.

If improperly wired, move resistor wire connection from "C" (wiper) to "R" terminal on rheostat when viewed from switch end with terminals pointed down. See Figure "B" for clarification.
