SIM20-74  
DATE: 11-1-85

**SUBJECT: MOONEY AIRCRAFT ANNUNCIATOR PANEL, (I.A.I.),  
REPLACEMENT OF RESISTOR VALUES FOR PRINTED CIRCUIT BOARDS TO ALLOW "PRESS TO TEST"  
FUNCTIONS TO WORK PROPERLY.**

**MODELS/S/N AFFECTED: Mooney Aircraft Models**  
M20J S/N 24-0378 through 24-0900  
M20K S/N 25-0001 through 25-0246

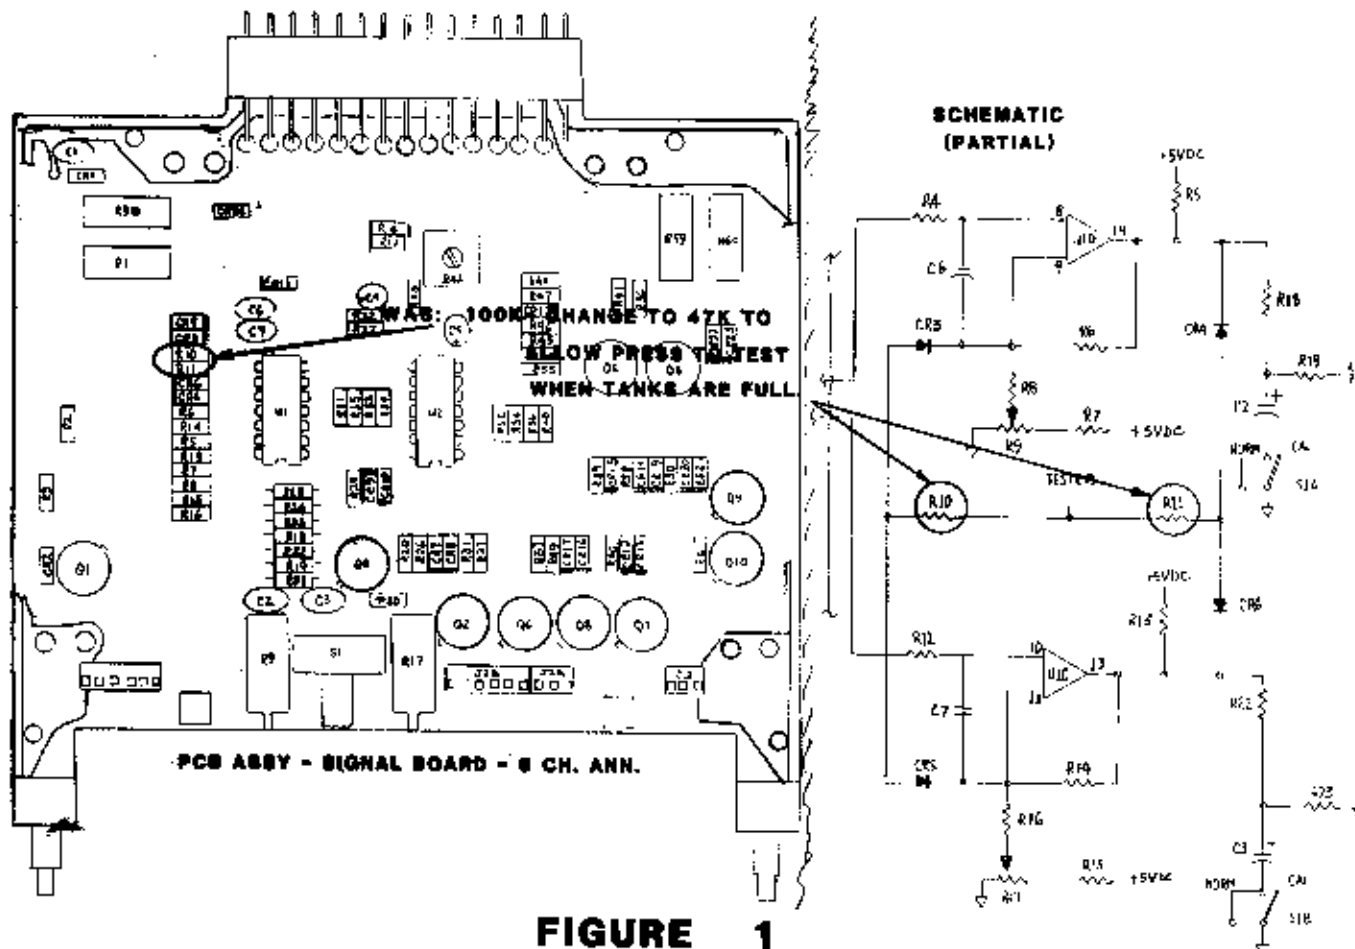
**FIGURES/TABLES: See Figure 1**

**INTRODUCTION: Due to component aging in the annunciator panel, some aircraft may experience failure of the "Low Fuel" warning lights. The most noticeable indication will be the inability to obtain "Low Fuel" lights from one or both warning lights when the Press-to-Test switch is depressed.**

Resistors R10 and R11 were originally 100K value resistors. I.A.I. recommends changing to 47K value resistors. See Figure 1 for circuit board location and a partial schematic for functional operation as reference.
