SERVICE INSTRUCTION M20-92

**SUBJECT:** REPLACEMENT OF TORSION SPRING IN DRIVE CLUTCH ASSEMBLY OF GEC (PLESSEY) LANDING GEAR ACTUATORS, MOONEY P/N 880037-505 AND 880037-507.

# SERVICE INSTRUCTION

SI-11

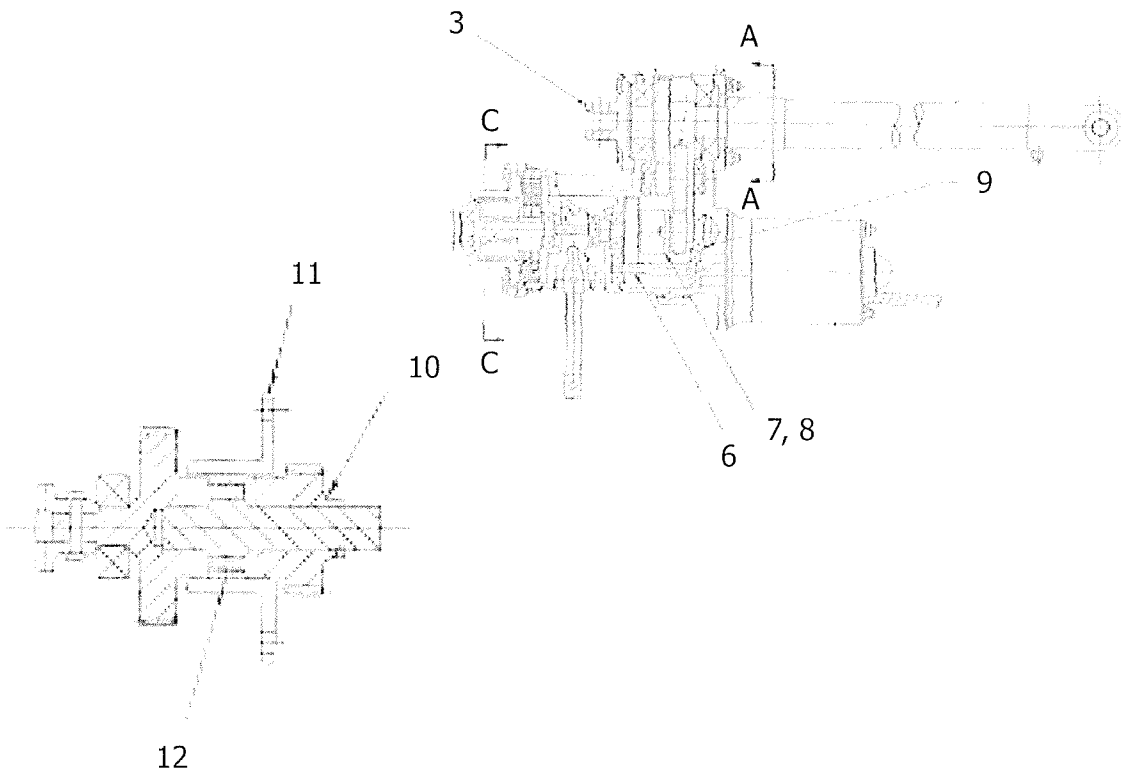
REASON- Two torsion spring failures reported at 1200 and 1500 flight hours.

- 1) Using a razor or sharp knife slice through identification plate.
- 2) Remove eight bolts (1) and eight self-locking nuts (2) from fixed end fitting (3). Discard self-locking nuts.
- 3) Remove fixed end fitting (3). Leave retaining plate on opposite end on screw assembly.
- 4) Remove two bolts (4) and two self-locking nuts (5) that secure housings together. Discard self locking nuts.
- 5) Separate housings and remove pinion (6) with attached bearings.
- 6) Cut lockwire and remove two screws (7) and drive clutch assembly (8) with shims (9).

- 1) Remove spur clutch gear (10), clutch housing (11), and torsion spring (12). Discard torsion spring.
- 2) Clean all removed parts thoroughly.

- 1) Install new torsion spring (12), identified with yellow pinion in ID with tab against stop.
- 2) Re-install clutch housing (11) and spur clutch gear (10).

- 1) Install shims (9) and clutch drive assembly (8) into ball bearing of motor housing. Secure with screws (7). Torque screws 18 to 22 in-lb. Lockwire screw (7) to screw (7).

- 2) Install pinion (6) with attached ball bearings into slot of motor assembly.
- 3) Coat all gears and fill cavity between housings with grease per Military Specification MIL-G-81322.

- 4) Install housings together by lining up ball bearings and slot of drive clutch assembly. Do not use force to join housings.
- 5) Install two bolts (4) and two new self-locking nuts (5) to secure housings together. Torque bolts 60 to 75 in-lb.

- 6) Install fixed end fitting (3) and line up with retaining plate on jackscrew end. Install eight bolts (1) and eight new self-locking nuts (2). Torque bolts 60 to 75 in-lb.

- 7) After testing of actuator apply a coat of F-1000 sentry seal across face of self-locking nuts (5) and bolt threads (4), and the four middle self-locking nuts (2) and bolt threads (1).
