NUMBER: S.I. M20-63  
DATE: 4-12-83

**SUBJECT:** ENGAGEMENT OF BAGGAGE DOOR AUXILIARY EXIT LATCHING MECHANISM.

**MODELS/SERIAL NUMBERS AFFECTED:** Mooney M20J S/N 24-0084, 24-0378 through 24-1381. Mooney M20K S/N 25-0001 through 25-0754.

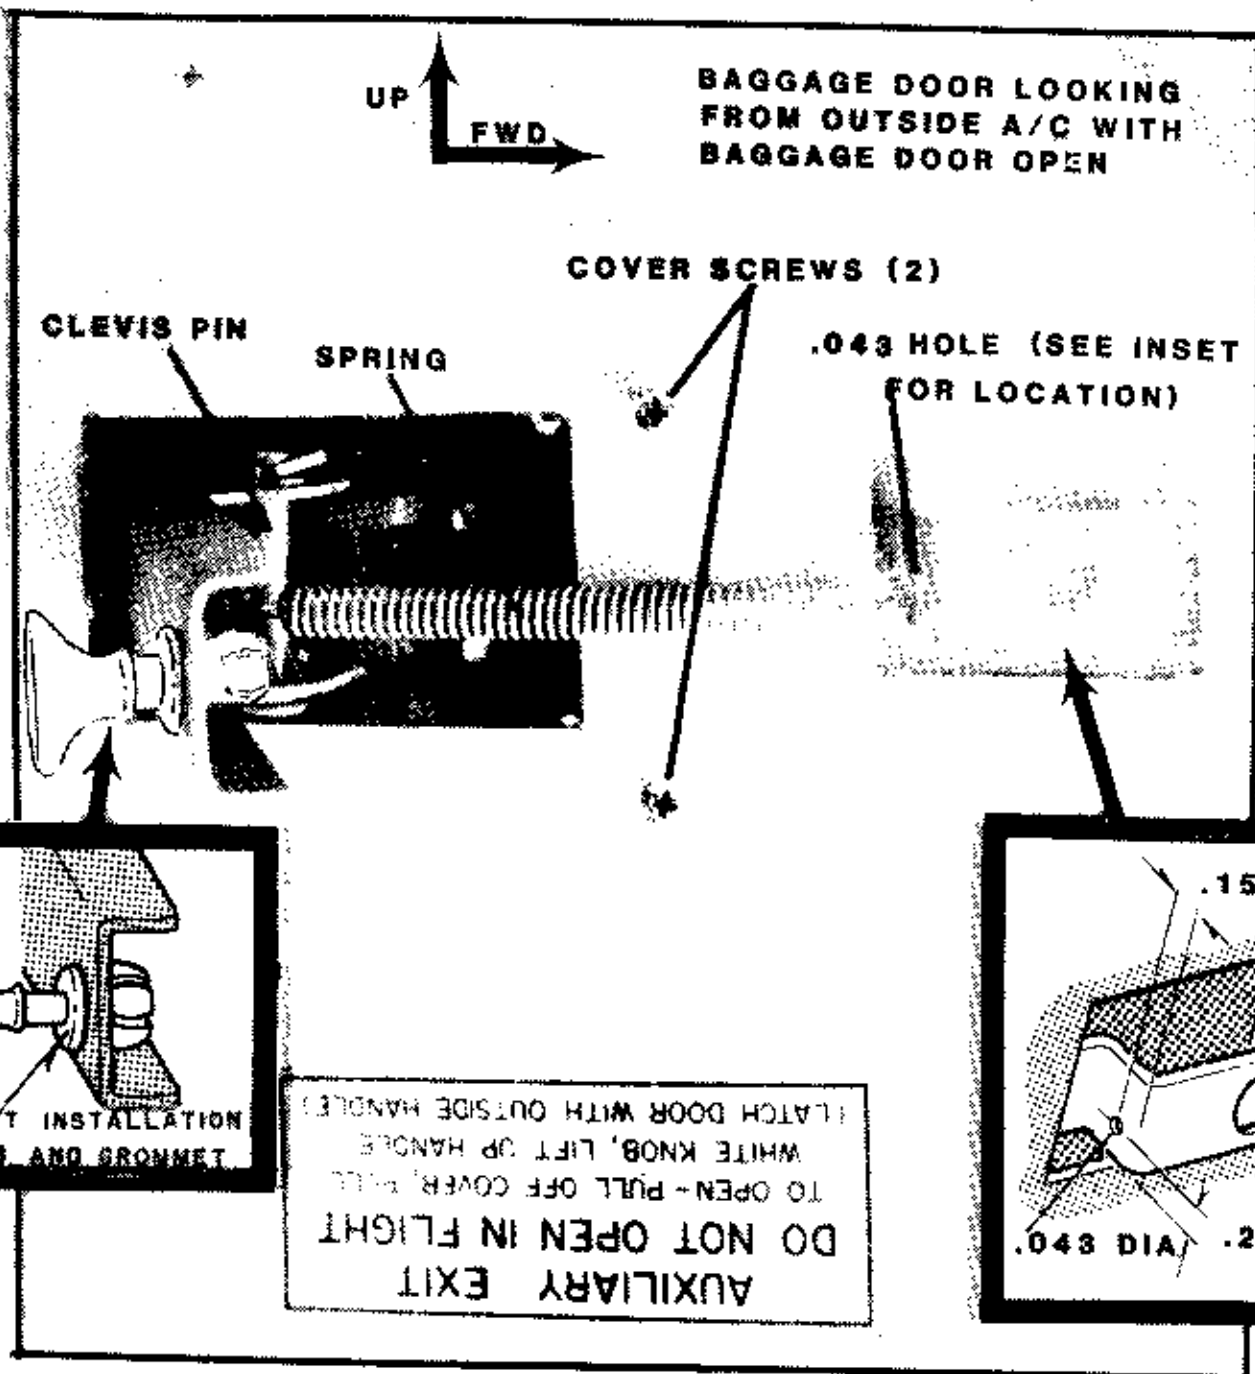
FIGURE 1

**INTRODUCTION:** Reports have been received that baggage doors have come open during takeoff or in flight conditions. These have been traced back to improper re-engagement of the latching pin into the outside handle cam assembly after demonstration or use of the inside auxiliary exit handle. The purpose of this S.I. is to install a positive means of pin engagement whenever the auxiliary exit handle is activated. The latching pin will be spring loaded back into the cam slot of the outside baggage door handle assembly.

3. Check white plastic (nylon) knob and grommet to verify correct installation. (See figure 1).
4. Pull red handle fully open; mark, center punch and drill a .043 dia. hole in the clip, P/N 350191-5, (see figure 1 insert for location).

5. Attach LE-029C-6 spring to clip at new hole.
6. Attach other end of spring to 350190-1 new clevis pin which engages into cam slot of outside handle assembly.  
NOTE: The existing AN393-35 clevis pin will require removal from handle assembly to allow the new pin to be used. (see figure 1).

9. When working properly, snap the white grommet into large hole in clip, 350191-5, and push knob plunger into grommet to lock red handle in place.
10. Close outside handle while baggage door is open and see if both locking pins stick out approximately .625 inches or more from the door sides and that they can not be pushed back into the door with nominal hand force.
