SI M20-69 DATE: 11-10-83

SUBJECT: MOONEY M20J FUEL PRESSURE HOSE RETROFIT.

MODEL/SERIAL NUMBERS AFFECTED: MOONEY M20J S/N 24-0378 thru 24-1377.

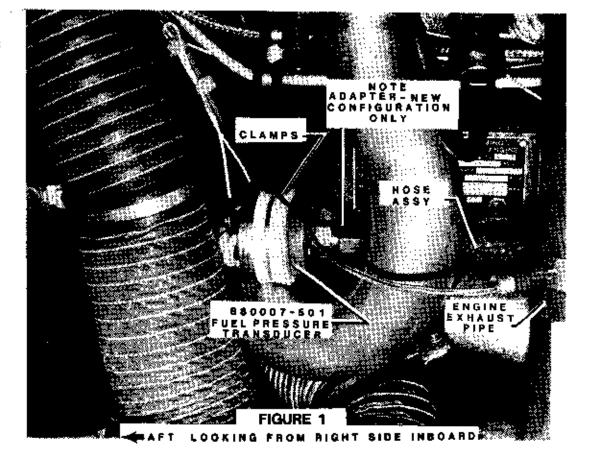
- 1. Remove top and bottom cowling per Service and Maintenance Manual.
- Remove and discard existing aluminum clamps from fuel pressure transducer, P/N 880007-501 and induction tube (See Figure 1).

- 3. Remove electrical wiring from the transducer terminals.
- 4. Remove fuel pressure transducer, 880007-501 from existing hose assembly, S94B90145 (See Figure 1).

- 7. Attach one of the new MS21919WCH25 steel clamps to the transducer and the other to the induction tube so they will fit together to secure the fuel pressure transducer. Use the existing hardware to attach the clamps (see Fig. 1).

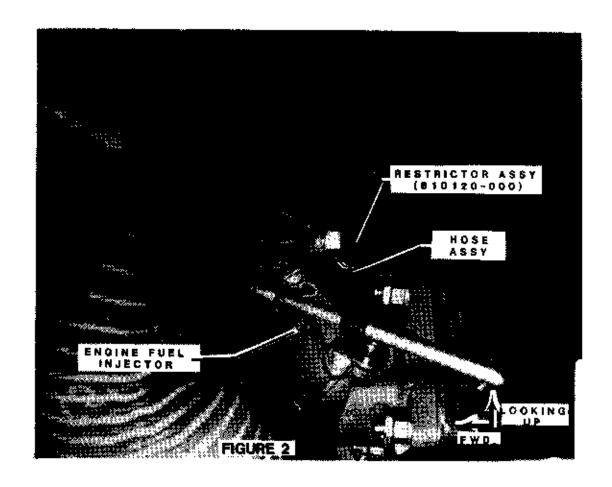
- Remove existing bose assembly, S94B90145, from restrictor (610120-000) on engine injector; leave restrictor on engine (see Fig. 2). Discard S94B0145 hose assembly.

- Attach new hose assembly, P/N 600375-27 to MS51503-B3 adapter and transducer, 880007-501. Attach the
 other end of hose assembly 600375-27 to the restrictor, 610120-000, on engine injector (see Fig. 2).
